Test Report

No.: XMHL250400243601SD

Sample Descriptions : HEATING MAT

Item No.(s) : H RTP SERIES

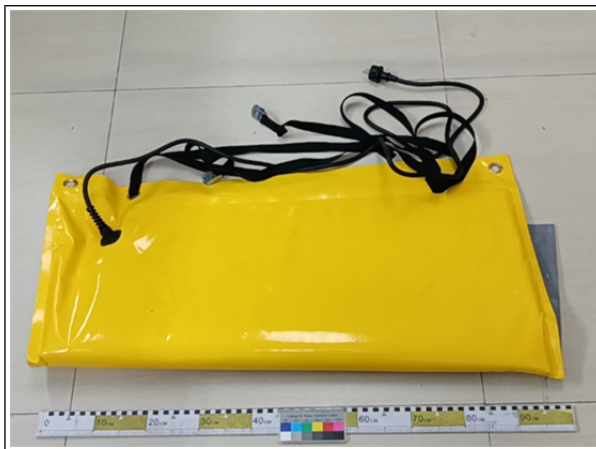
Original Sample-Sample A

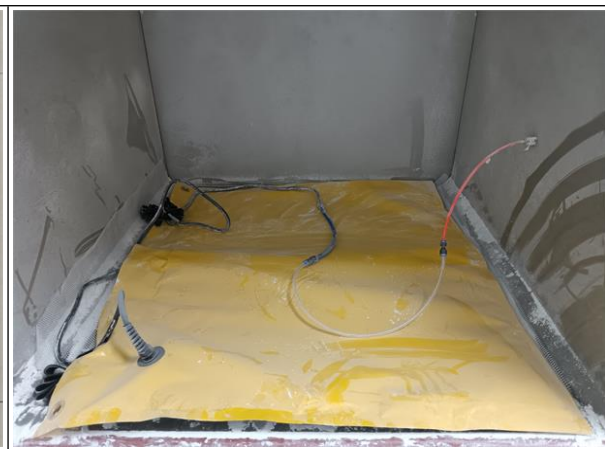
Test dust: Talcum powder

Dust concentration: 2 kg/m³ and suspended during the test

Depression: ≤2 kPa

Pumping speed: <40 volumes/h

Test duration: 8 h

During Test-Sample A

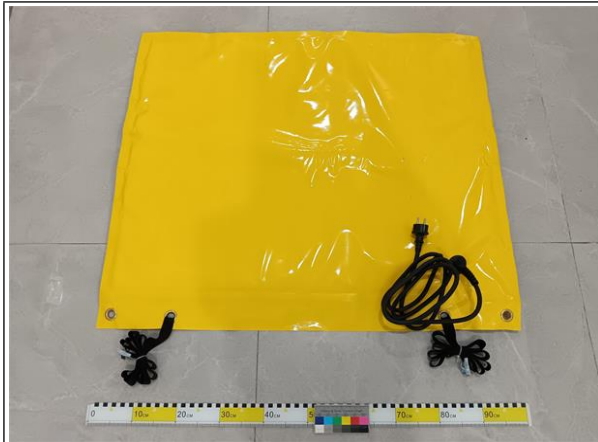
Before Test-Sample A

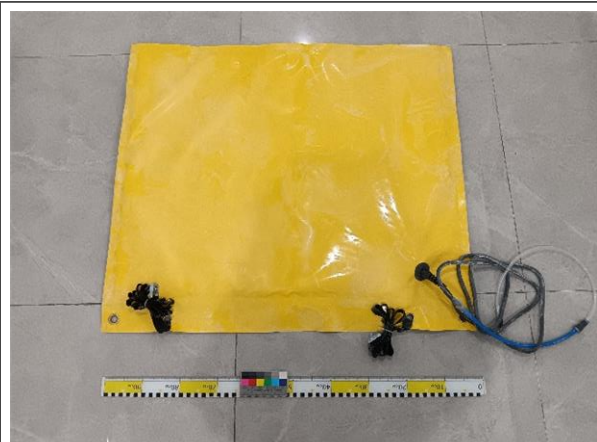
Specimen	Result	Client's Requirement	Conclusion
1	No visual ingress of dust.	No visual ingress of dust.	Pass

After Test-Sample A

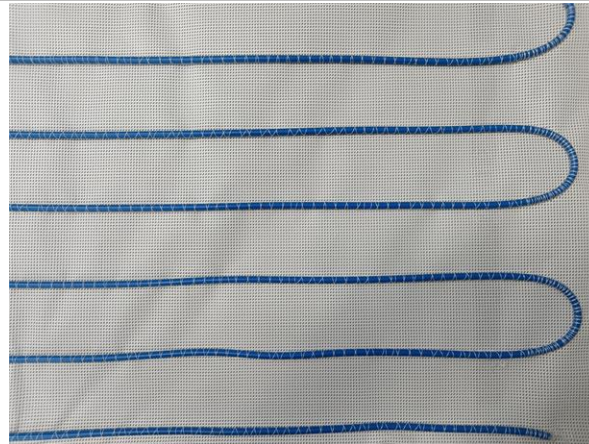
After Test-Local Part

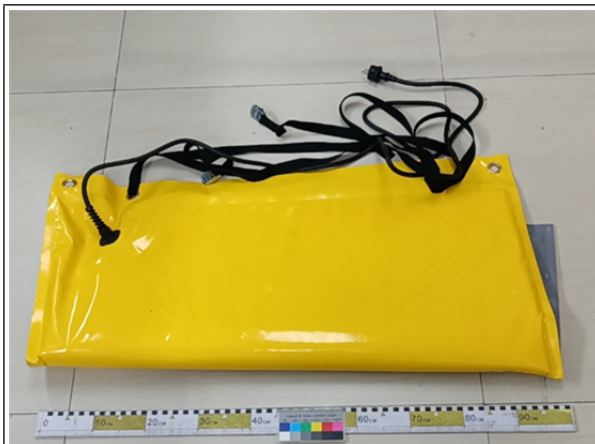
Original Sample-Sample A

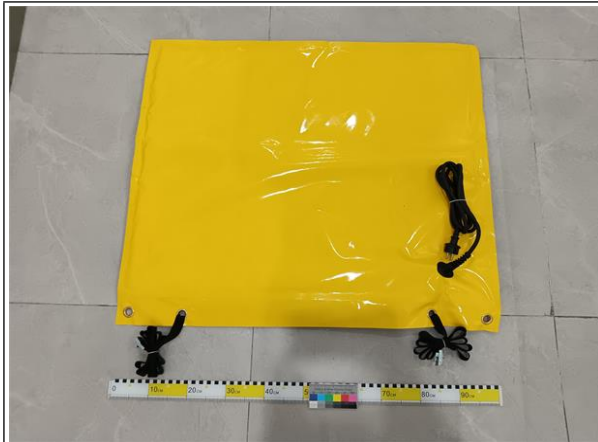
Before Test-Sample A
